ADVANCE REPORT  
on the  
SEDIMENTATION INVESTIGATIONS  
of  
RESERVOIRS AND NAVIGATION IMPROVEMENTS  
on the  
NEW RIVER, VIRGINIA AND WEST VIRGINIA

April 14 - May 22, 1936

Carl B. Brown and Farrell F. Barnes

Division of Research  
Section of Hydrodynamic Studies  
SCS-SS-6  
August, 1936

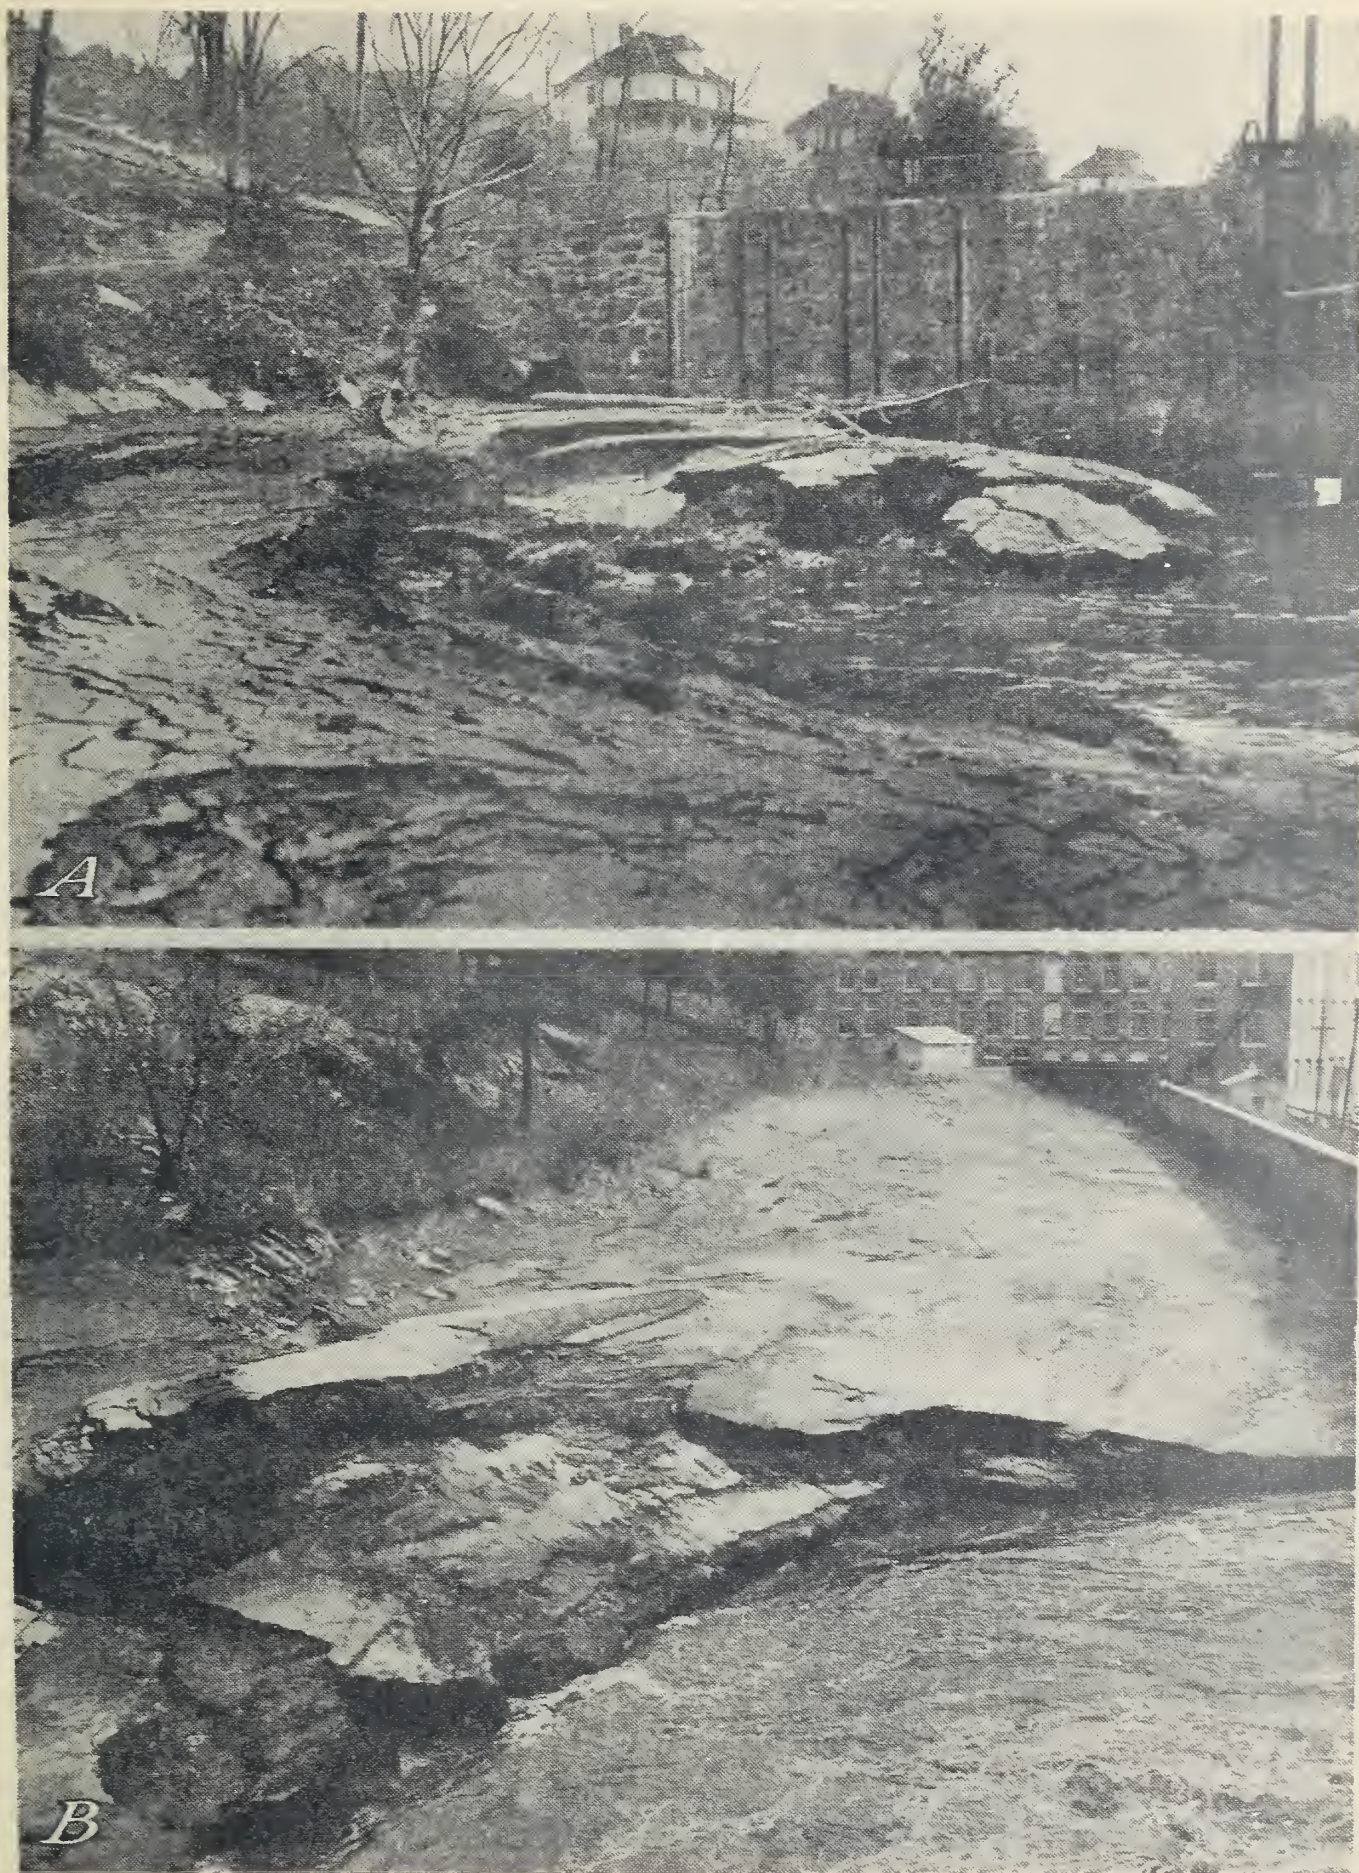
Figure 12.--A. Silt deposits just above the headgates at Washington Mills Dam, showing slumping caused by scour during draw-down. B. View of silt deposits in the forebay at Washington Mills Reservoir.

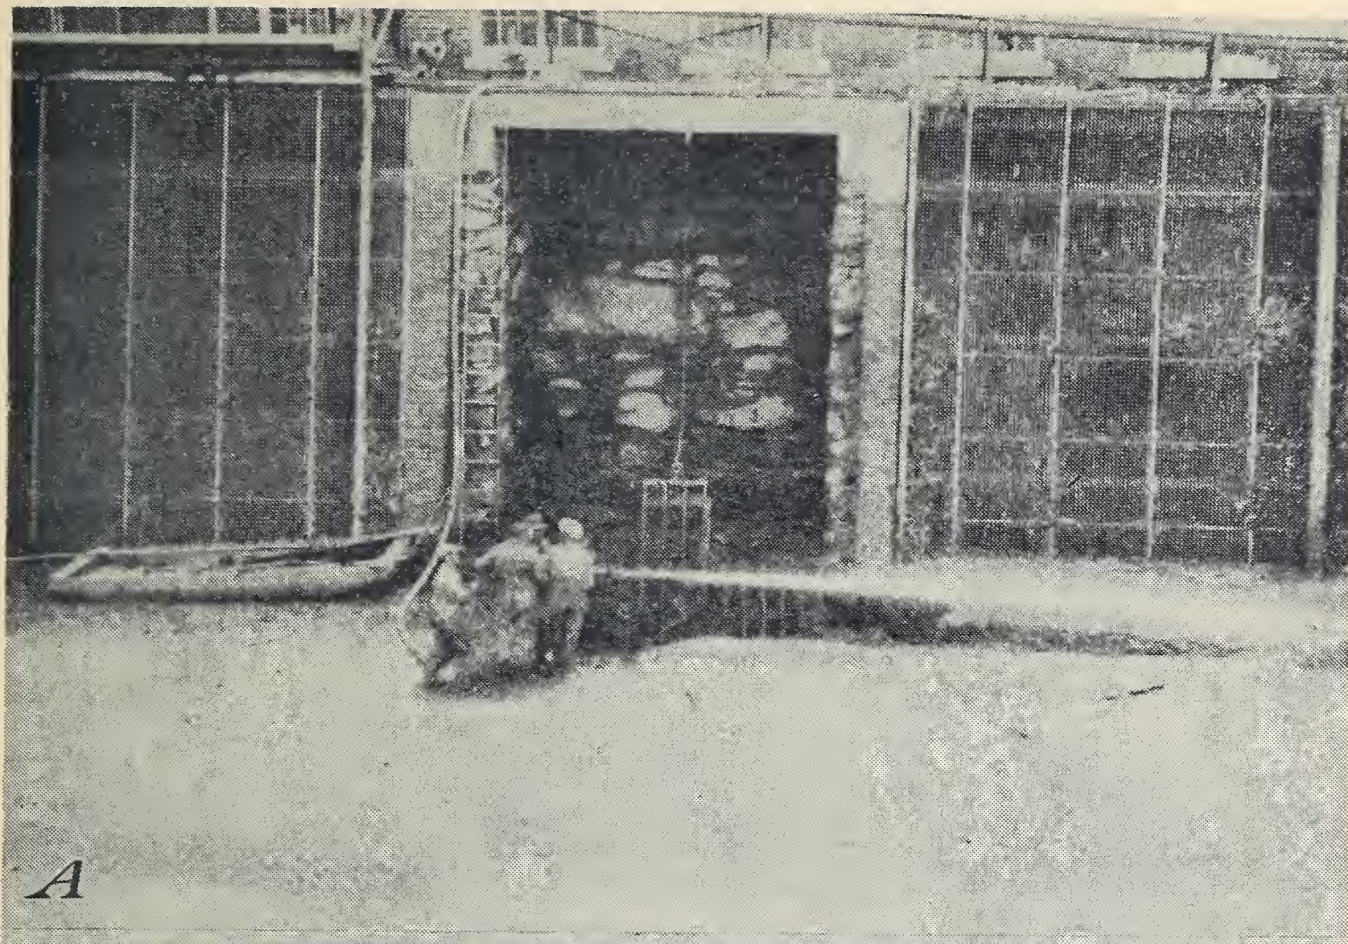
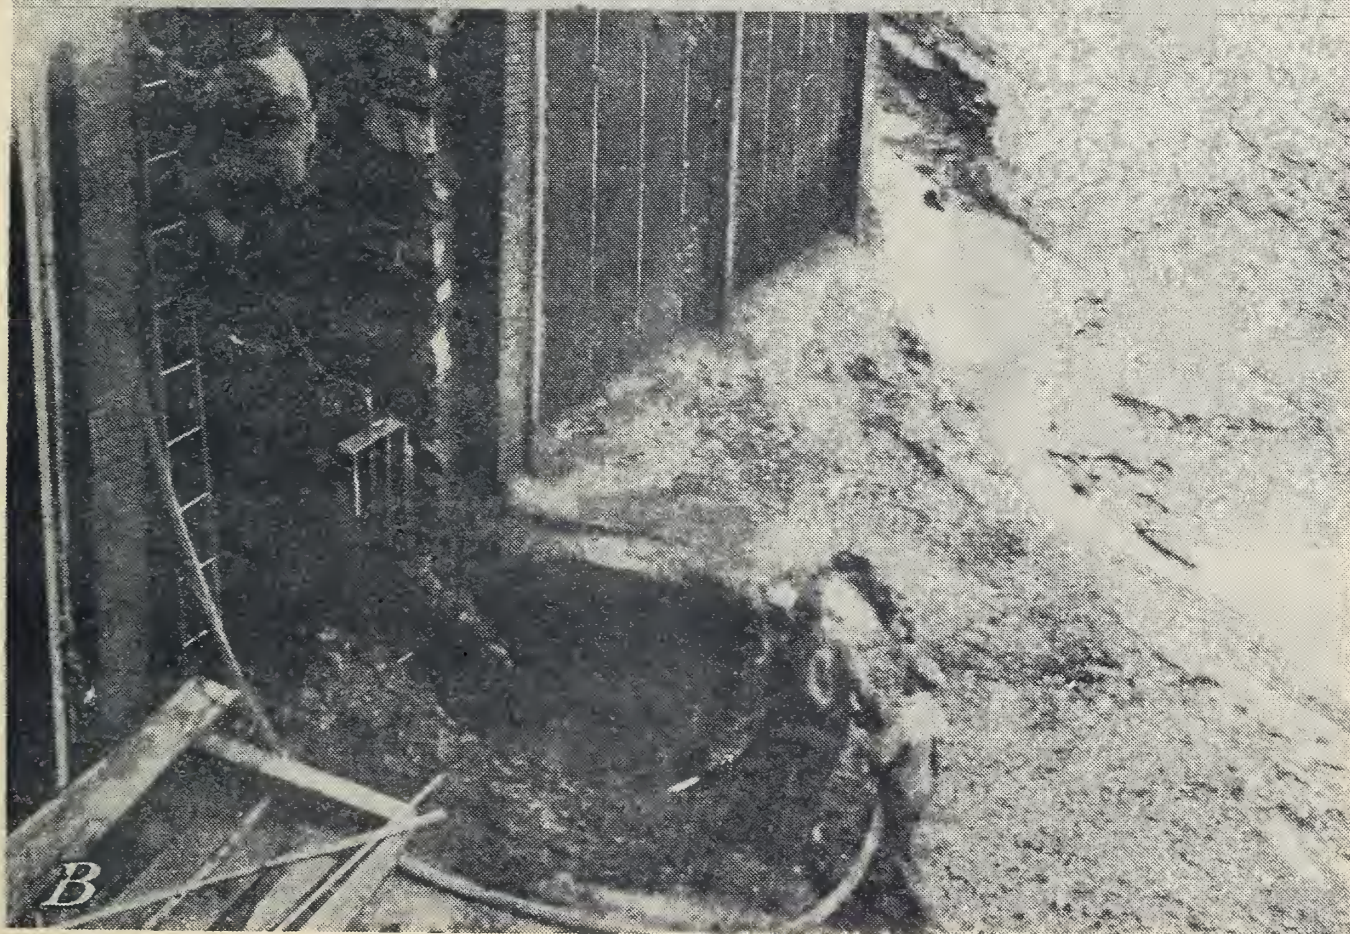
Figure 14.-A. View of foot of forebay at Washington Mills during draw-down, showing workmen hydraulicking silt from the mud valve. Six feet of silt accumulated between November 1935 and April 1936. B. View of foot of forebay at Washington Mills during draw-down, showing silt being hydraulicked from the mud valve.

Frequent shut-downs are required in order to sluice out the intake to the generators. Silt accumulates so rapidly in the forebay that a mud valve at the lower end, opened in November 1935, was found to be covered with 6 feet of mud when the valve was again opened 5 months later on April 18, 1936 (fig. 12-B). A fire hose is used to hydraulic the silt from the canal above the generators. This process is repeated on an average of 3 or 4 times a year (fig. 14).

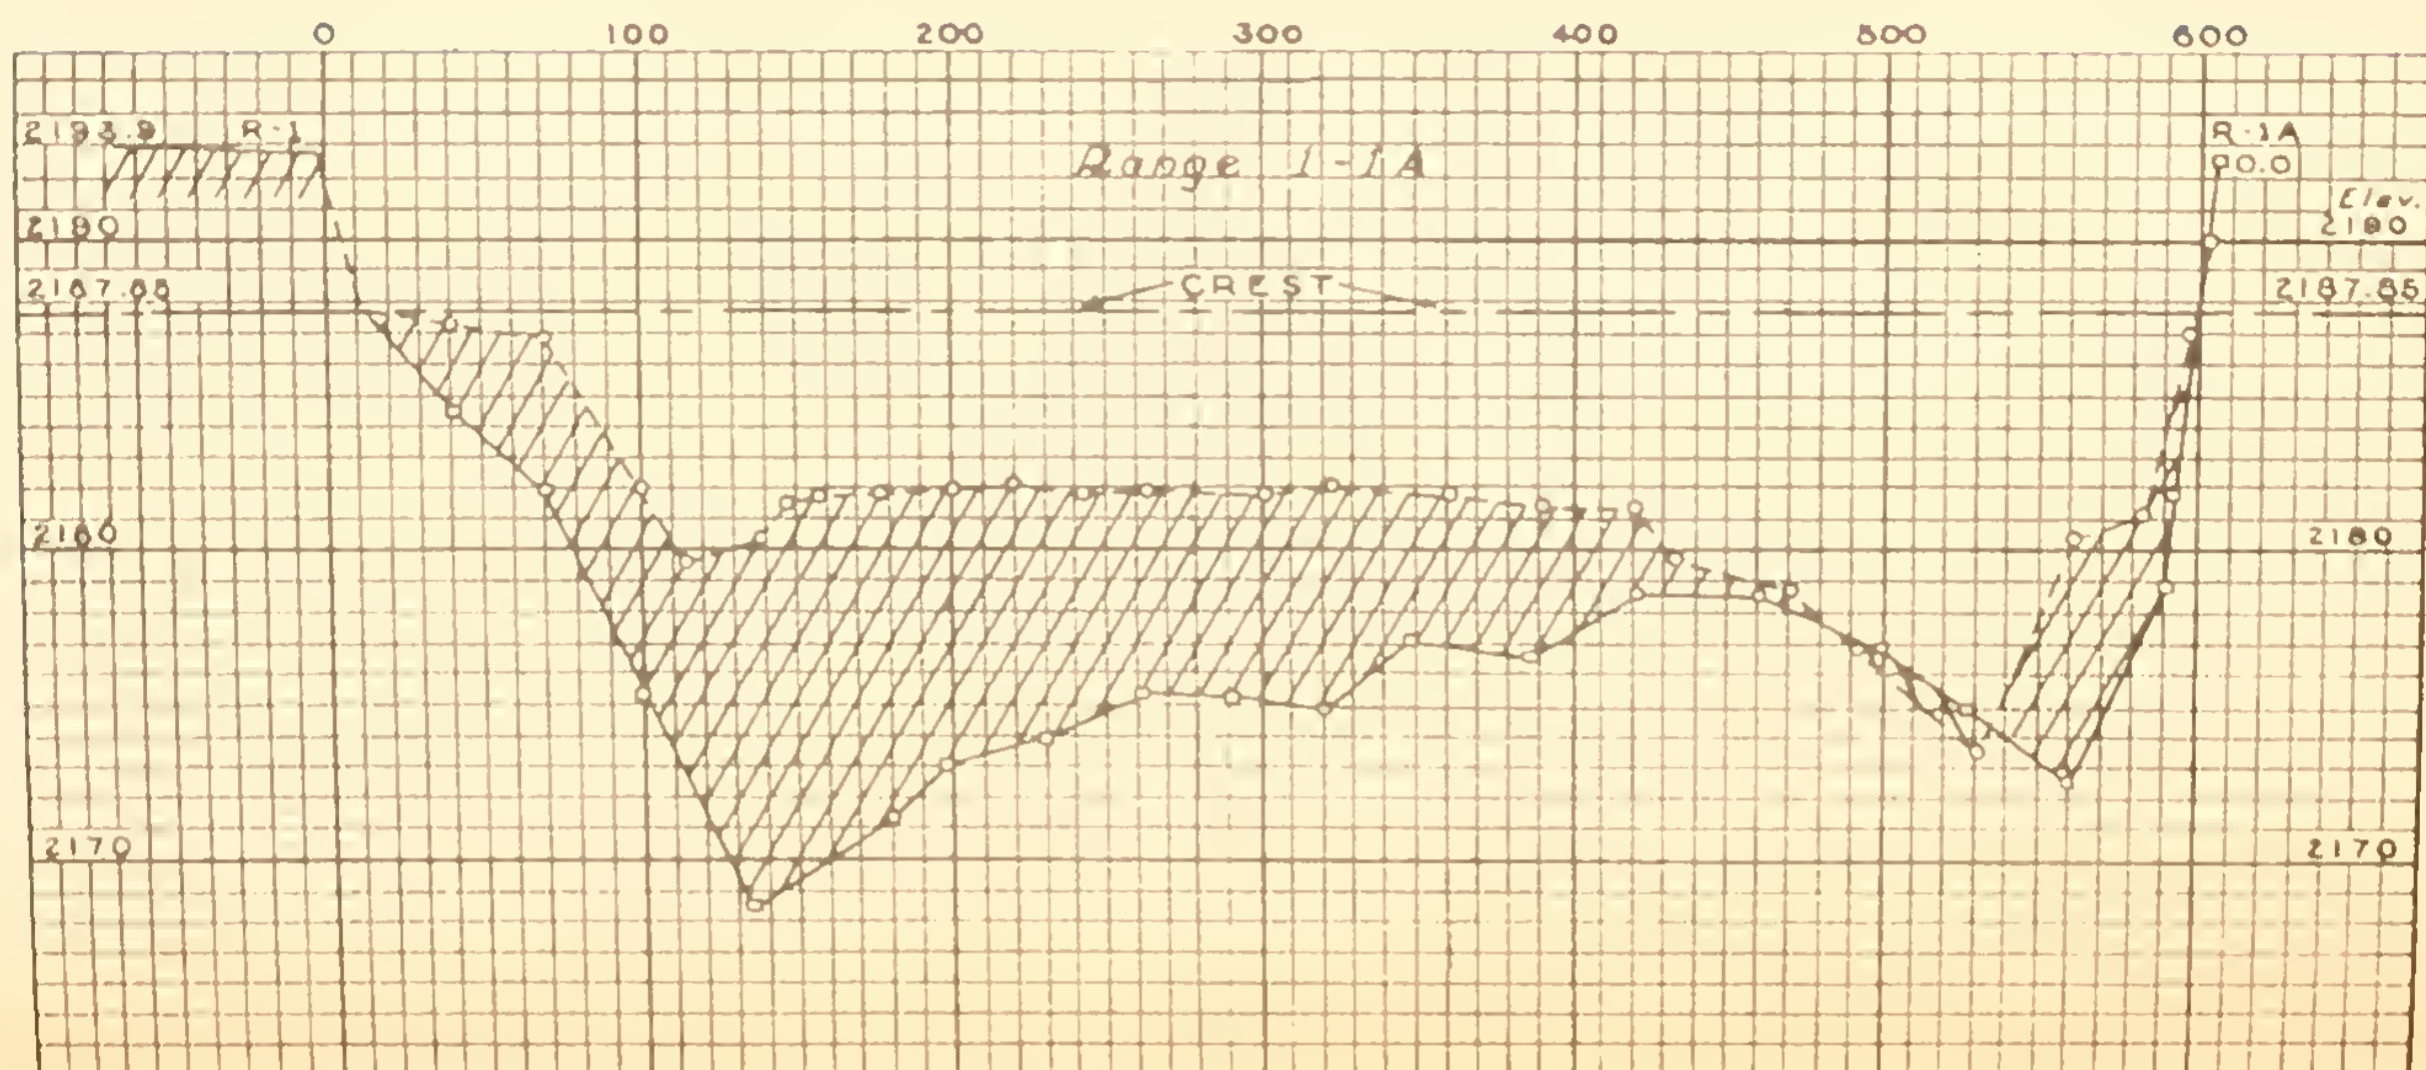
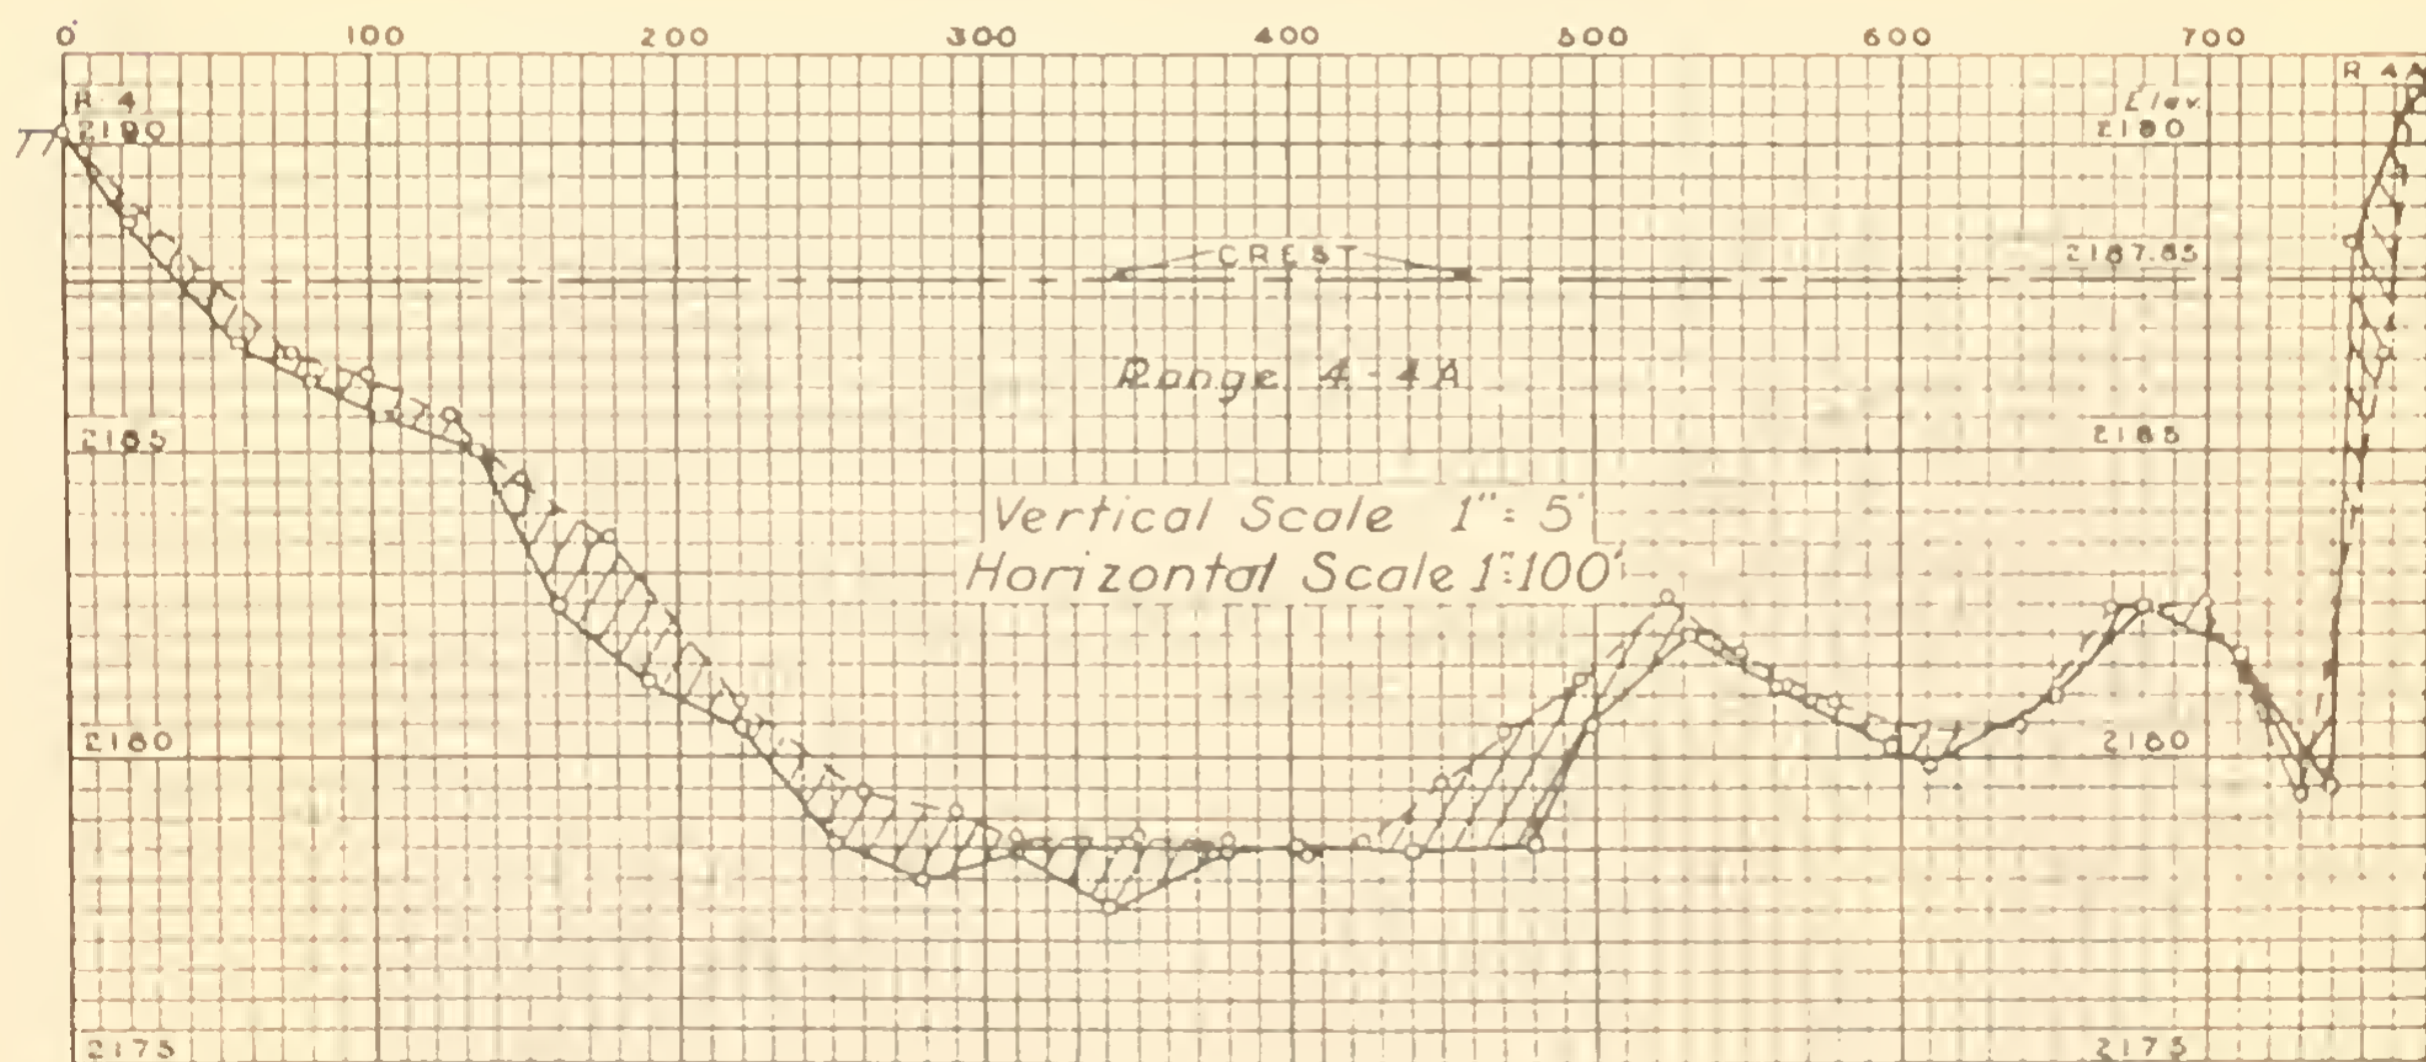
# CROSS SECTIONS OF WASHINGTON MILLS RESERVOIR FRIES, VA.

*Vertical Scale 1"=10'*  
*Horizontal Scale 1"=100'*

*Vertical Scale 1"=5'*  
*Horizontal Scale 1"=100'*

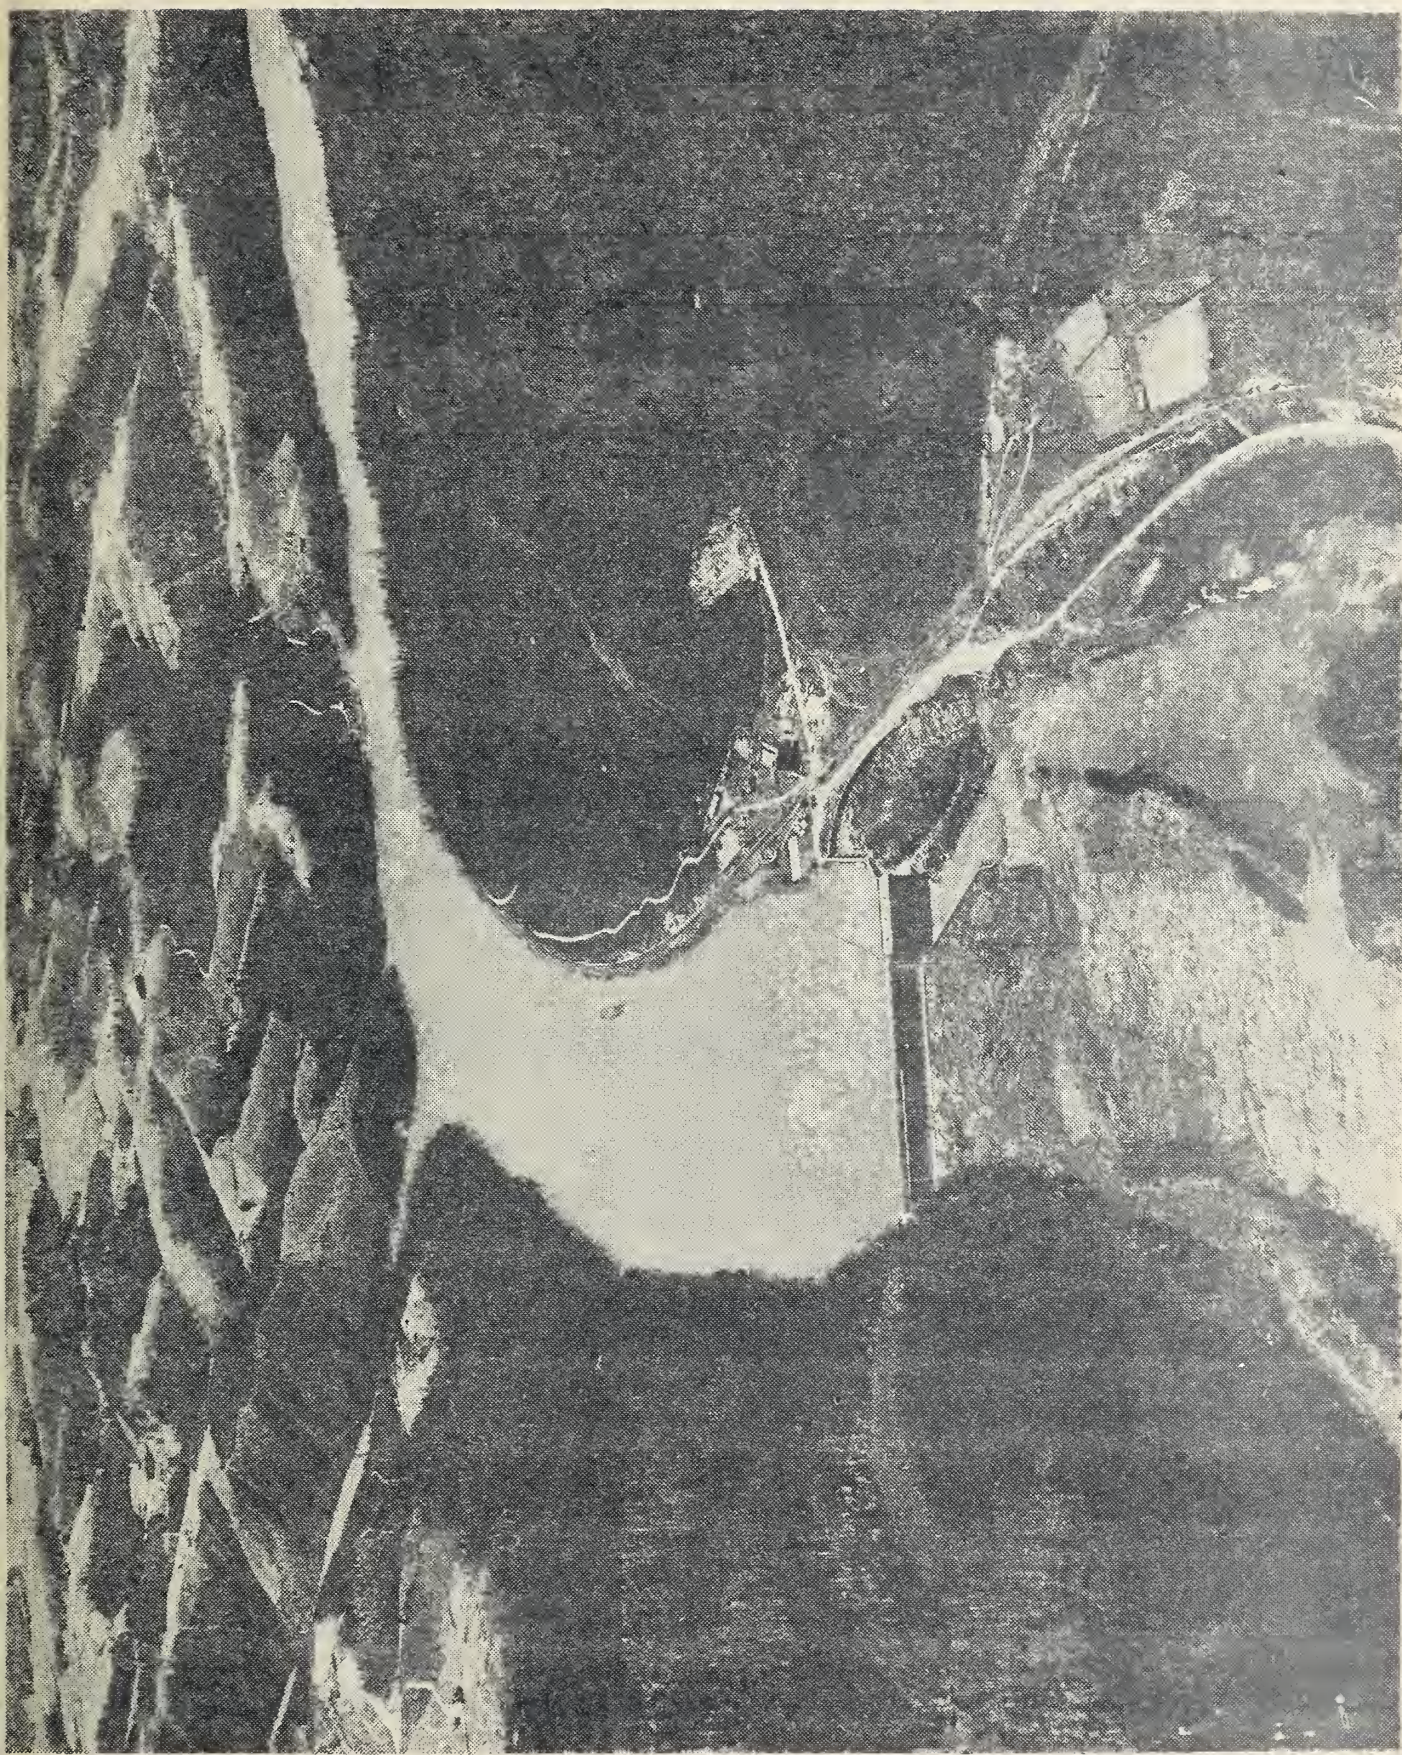
Figure 16. Aerial view of Byllesby plant and reservoir. Crooked Creek enters from the left. (Courtesy of Aerial Surveys of Pittsburgh, Inc.)

General Information. - The dam and reservoir are owned by the Appalachian Electric Power Company for the operation of their hydro-electric plant at Byllesby, Va. ( fig. 16). The reservoir was first filled in August 1912 so that the total age to date of survey is 23.66 years.

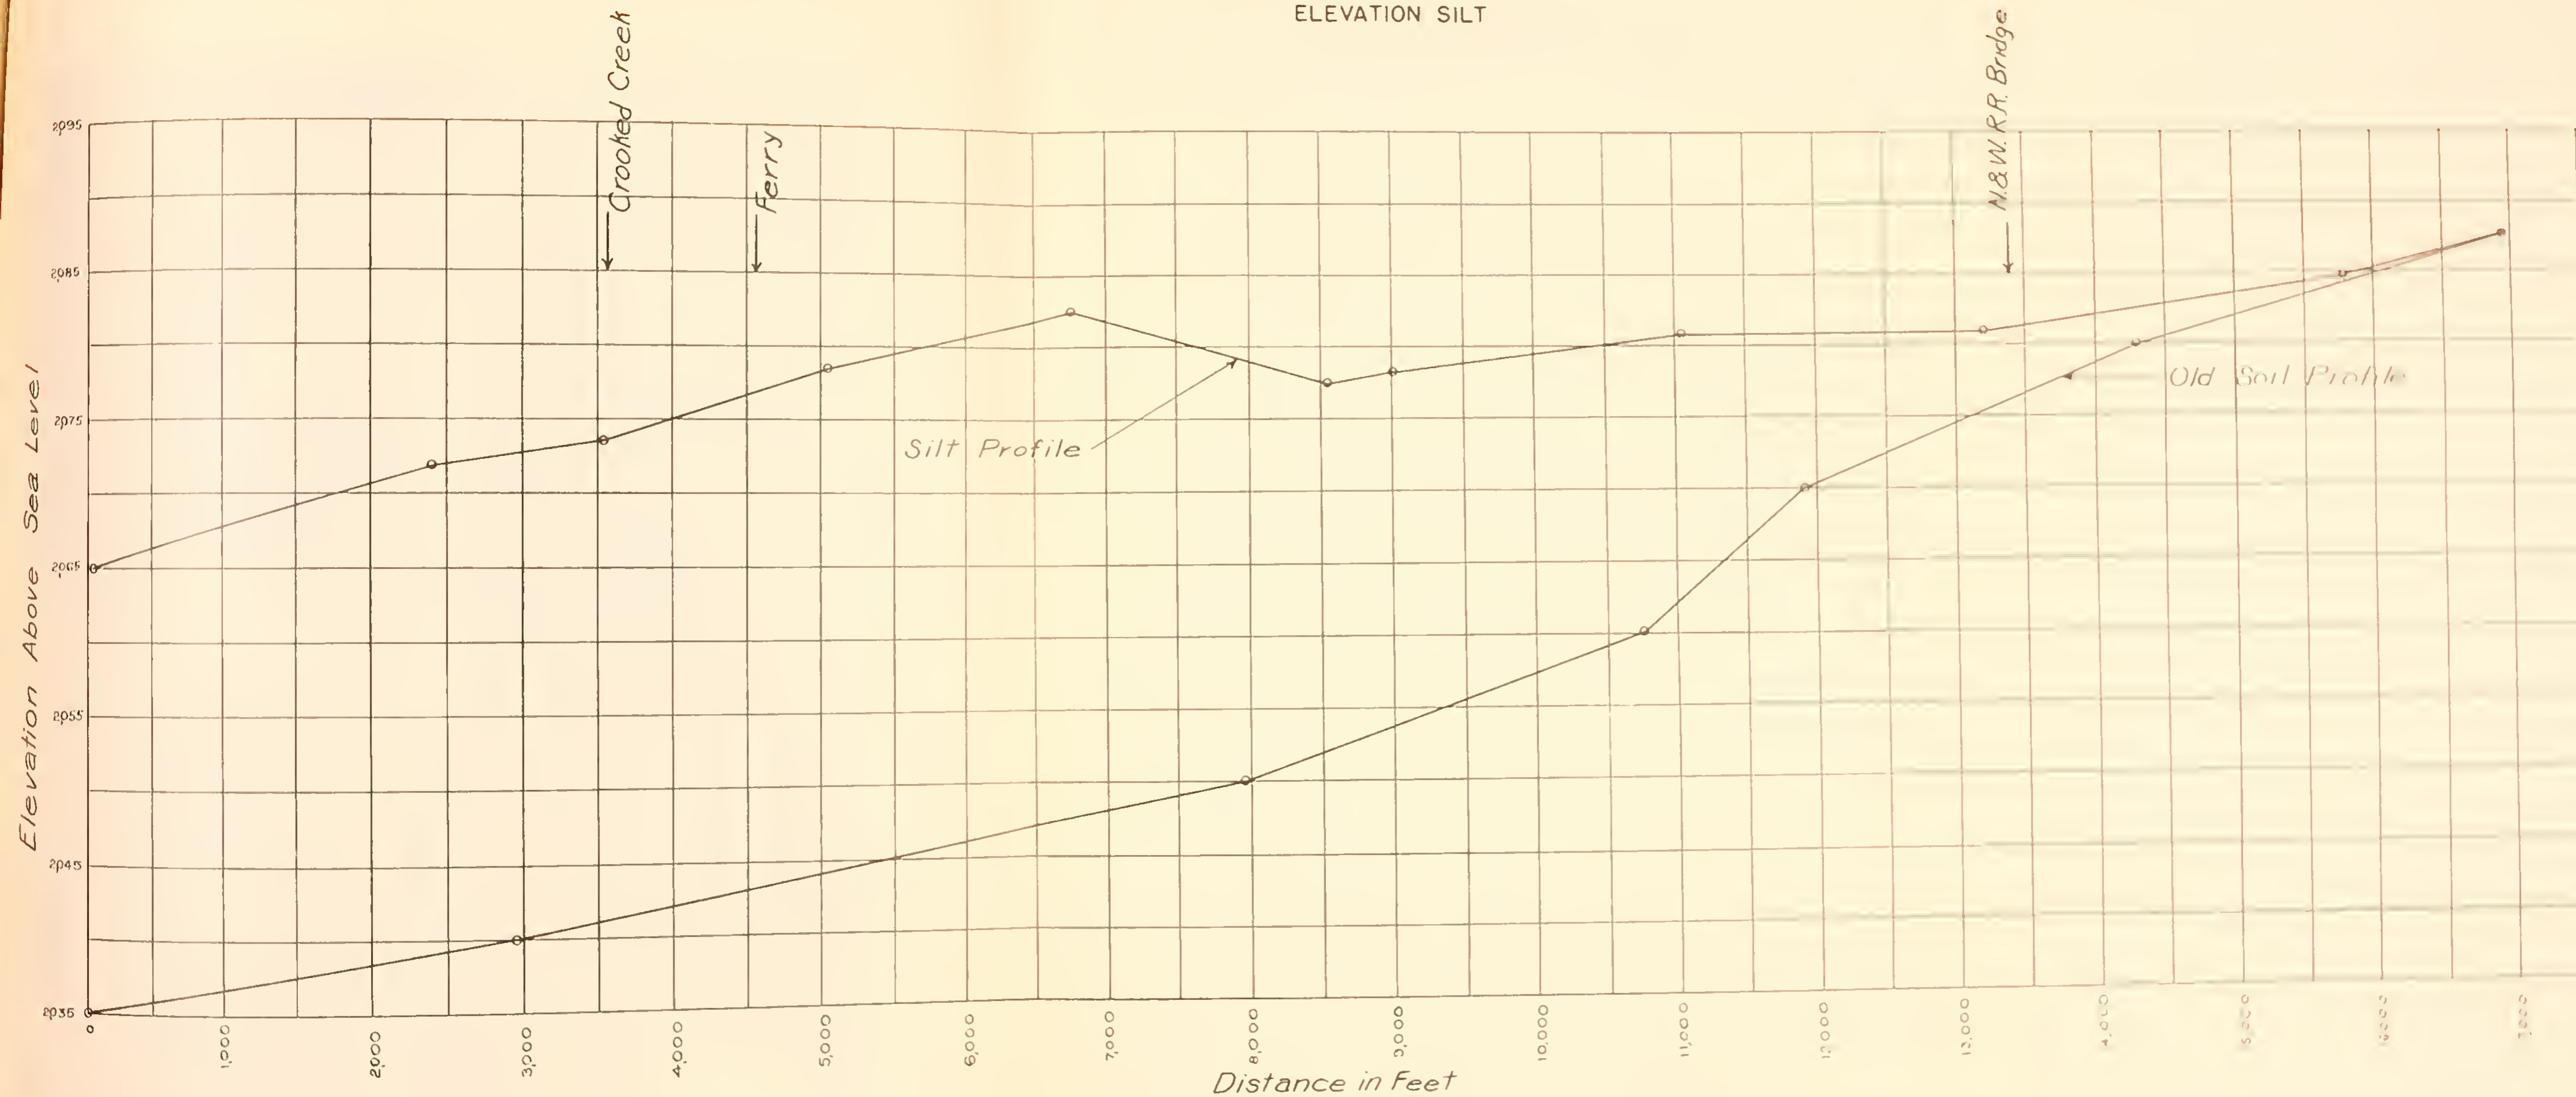
# LONGITUDINAL PROFILE OF BYLLESBY RESERVIOR

SHOWING: ELEVATION OLD SOIL  
ELEVATION SILT

Note: Silt profile plotted from cross section - average depth against distance  
Old soil profile plotted from original contours on base map

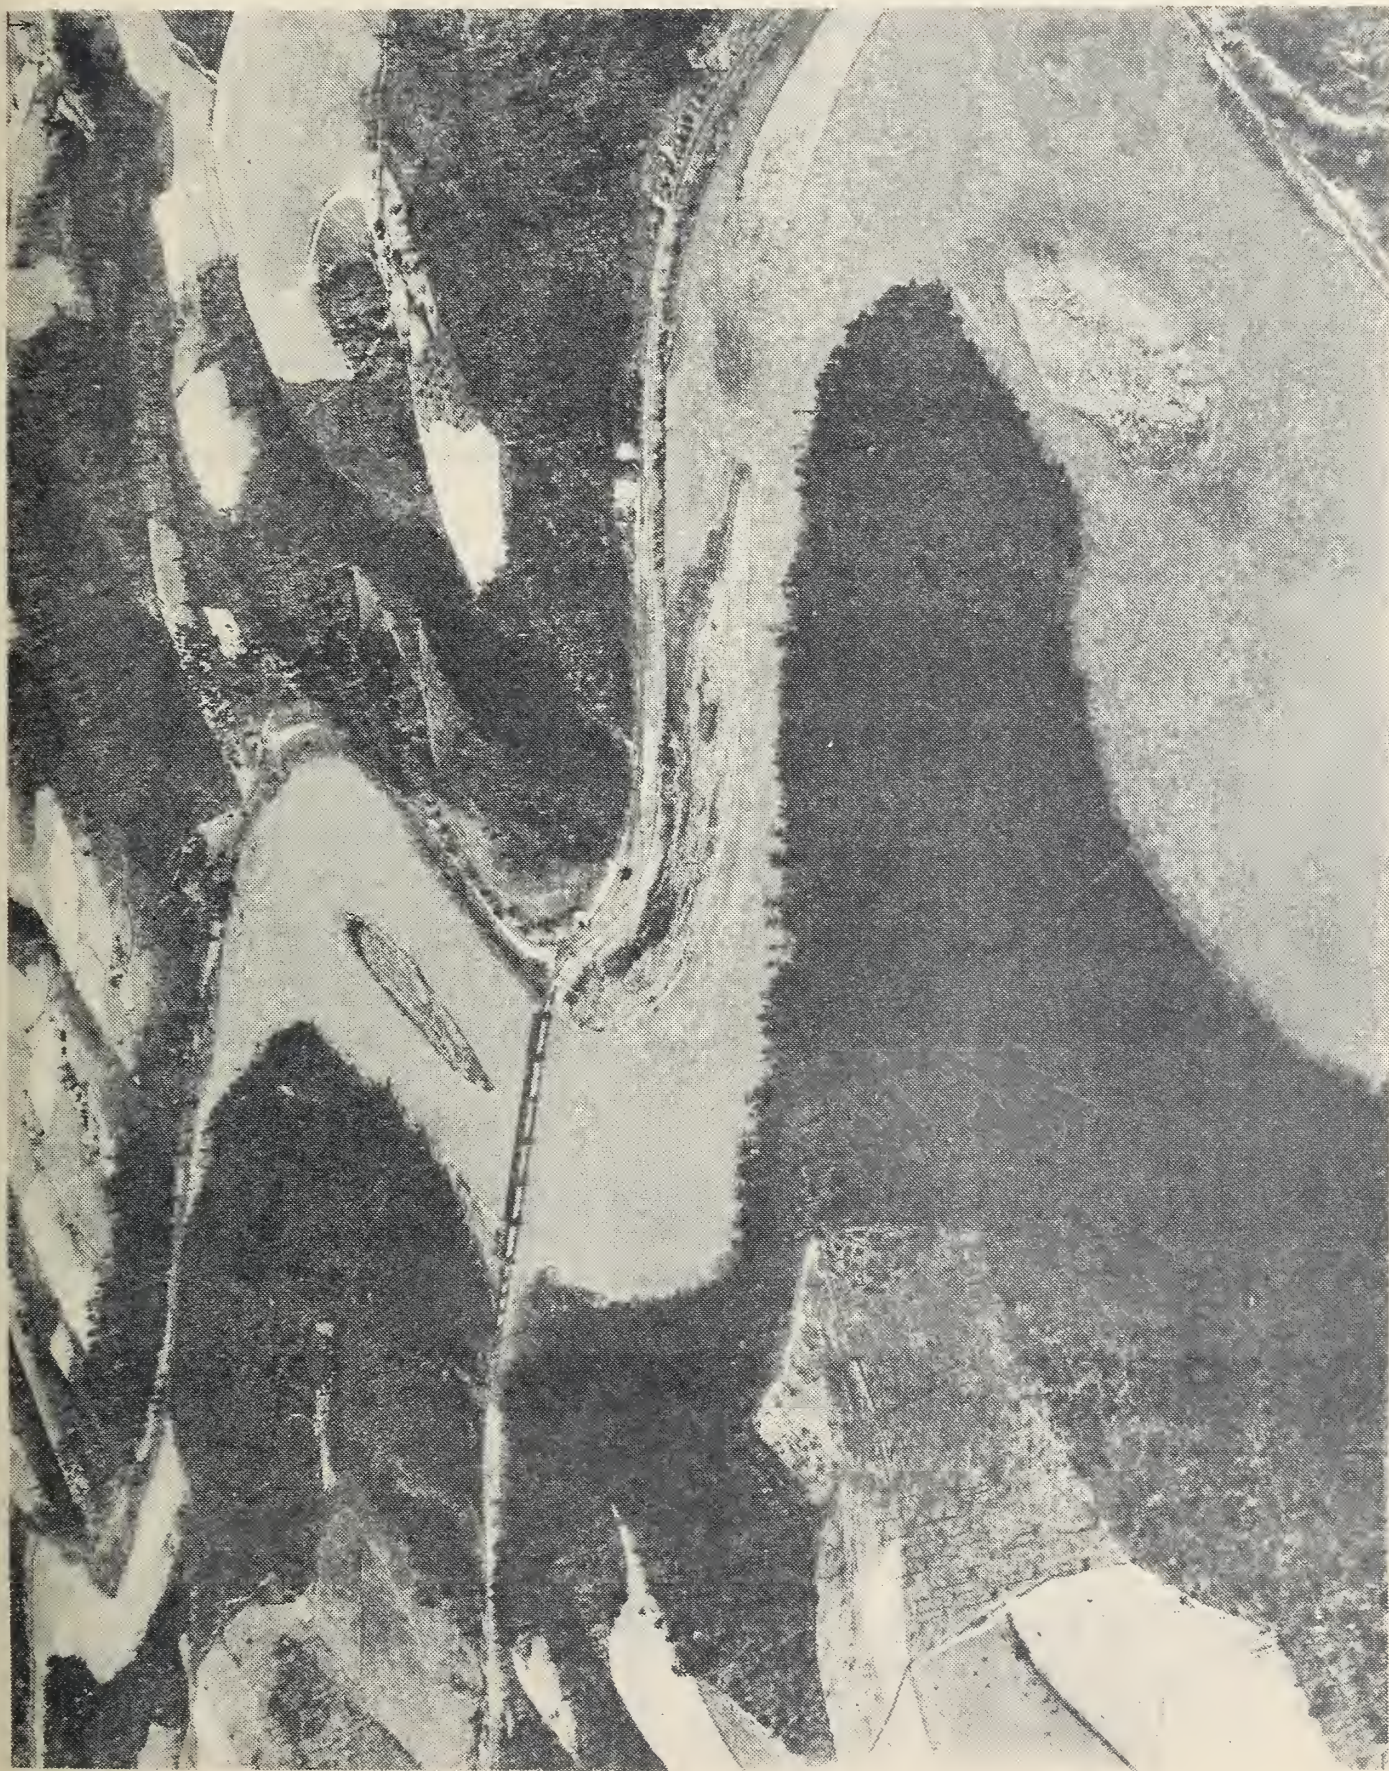
Figure 18. Aerial view of the upper end of Byllesby Reservoir, showing silt bars and islands. (Courtesy of Aerial Surveys of Pittsburgh, Inc.)

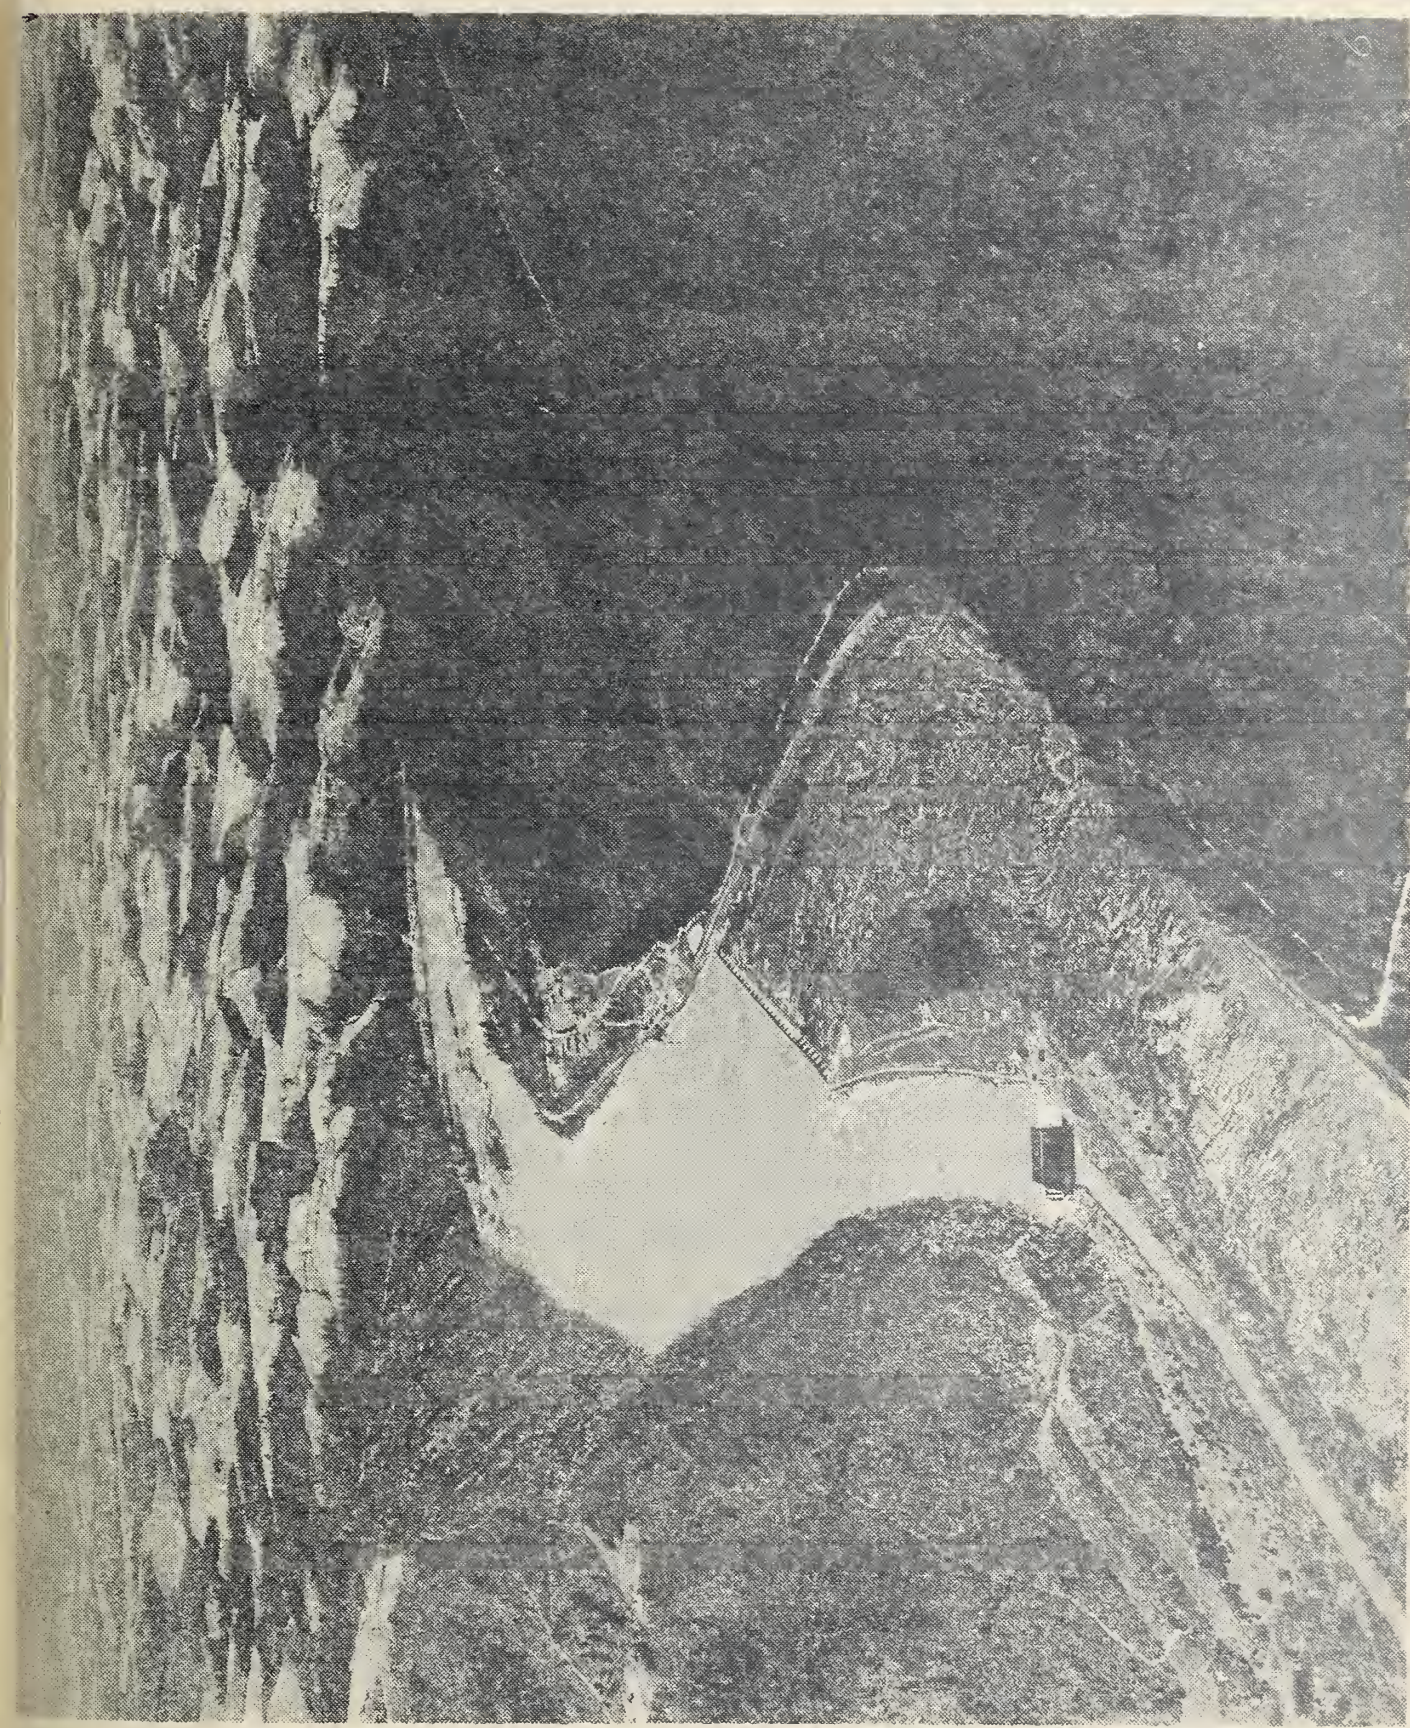
Figure 19. Aerial view of Buck plant and reservoir. Note the silt bars on the right bank and at the head of the forebay. (Courtesy of Aerial Surveys of Pittsburgh, Inc.)
